Hild und K

House in Aggstall Bavaria, Germany 2000

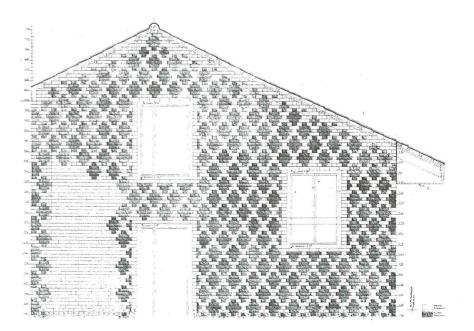
Below, left: Detail of whitewashed bricks wall. Photos on pp. 66–67 by Michael Heinrich. Below, right: Wall elevation. Opposite: View from Northwest.

The building is a solid construction made of lightweight wooden bricks with whitewashed full bricks. All the surfaces of the interior rooms have been provided with plaster. The solid construction continues on the roof: the tilted ready-made brick roof was topped by a roof.

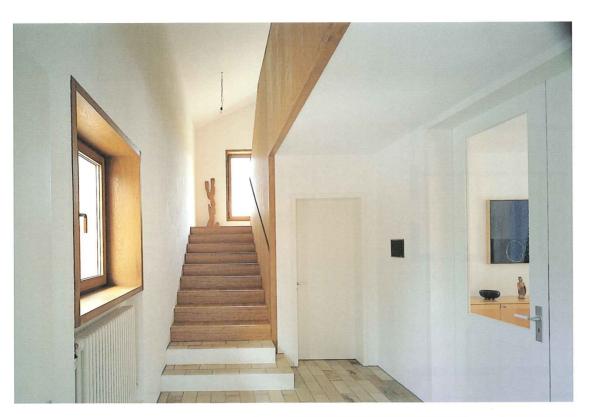
Above: View of staircase. Photos on pp.68–71 by Christian Gahl. Below: Bathroom at second floor. Opposite: Corridor at ground floor. View of door at end of corridor into bathroom.
